**U.S. ENVIRONMENTAL PROTECTION AGENCY
REGION III
CLEAN WATER ACT
COMPLIANCE INSPECTION REPORT**

Name of Facility: Super Salvage, Inc.
Facility Address: 1711 1st St SW Washington, DC 20024
Mailing Address: 1711 1st St SW Washington, DC 20024

Inspection Date: February 20, 2013
Entry Time: 1:40 pm EST
Exit Time: 3:30 pm EST

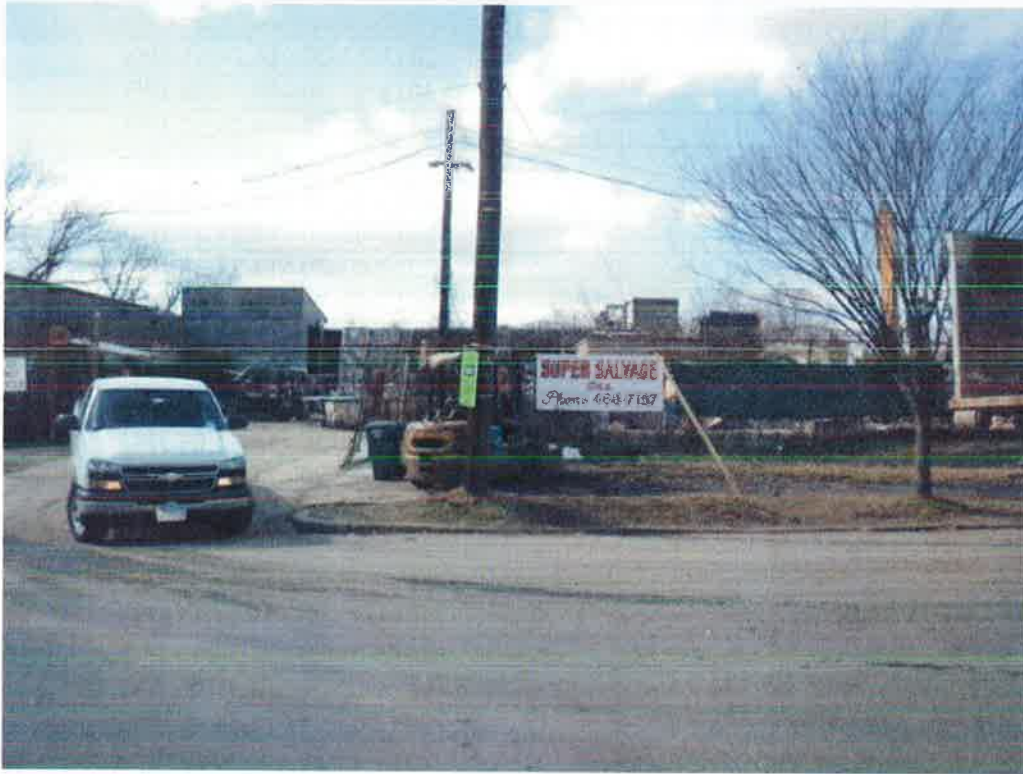
sediment entering a storm drain from the street (see Photograph 1, 53, 56, 58-64, and 79-81 in Appendix B).

Photograph 1. Facility sign and vehicle track out at Entrance 1.

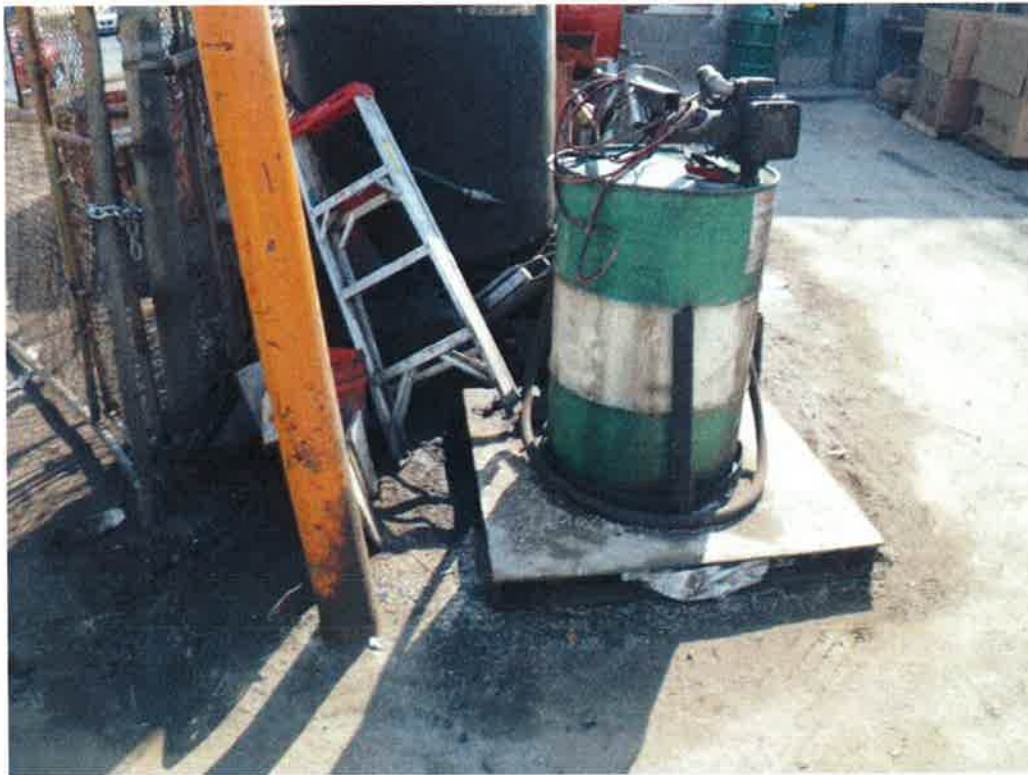
Observation 4: Super Salvage stored what appeared to be its used waste oil in an unlabeled plastic bin near Entrance 1 (see Photographs 71 and 72 in Appendix B). Several unlabeled open buckets and drums that were labeled as lubricants were also stored by the entrance on wooden pallets. It was unclear to the EPA inspection team whether the contents inside of these drums were lubricants (see Photographs 3, 4, and 70).

Photograph 3. **Barrel on wooden pallets at Entrance 1 of the site.**

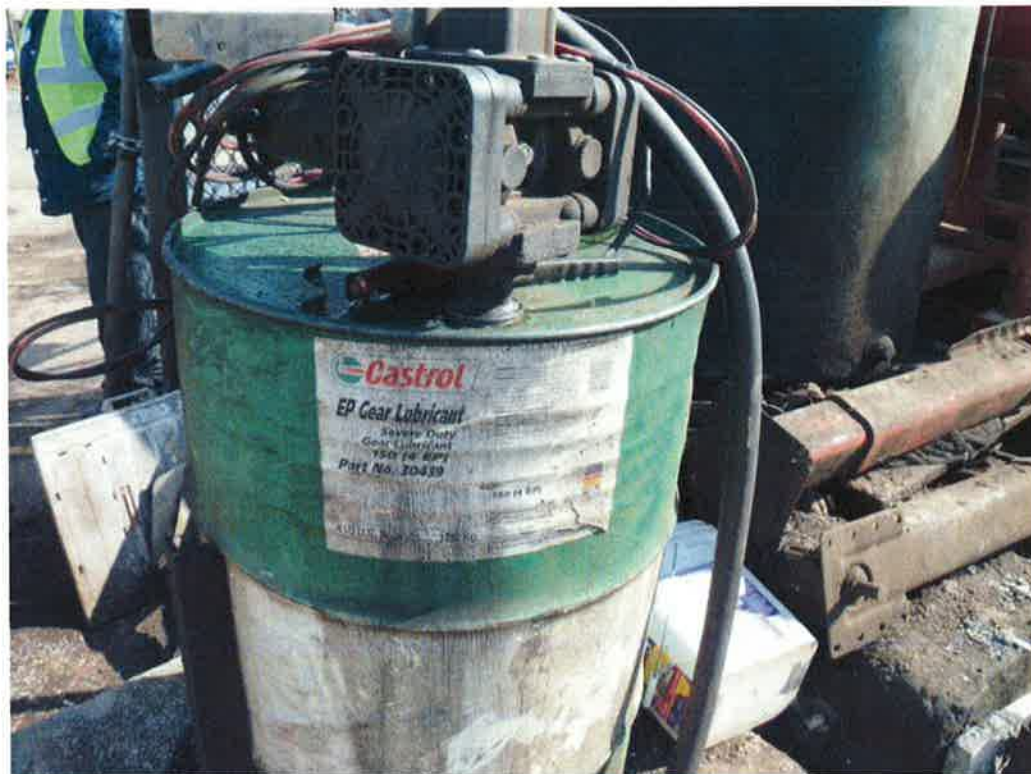
Photograph 4. **Close up view of the lubricant label on the barrel in Photograph 3.**

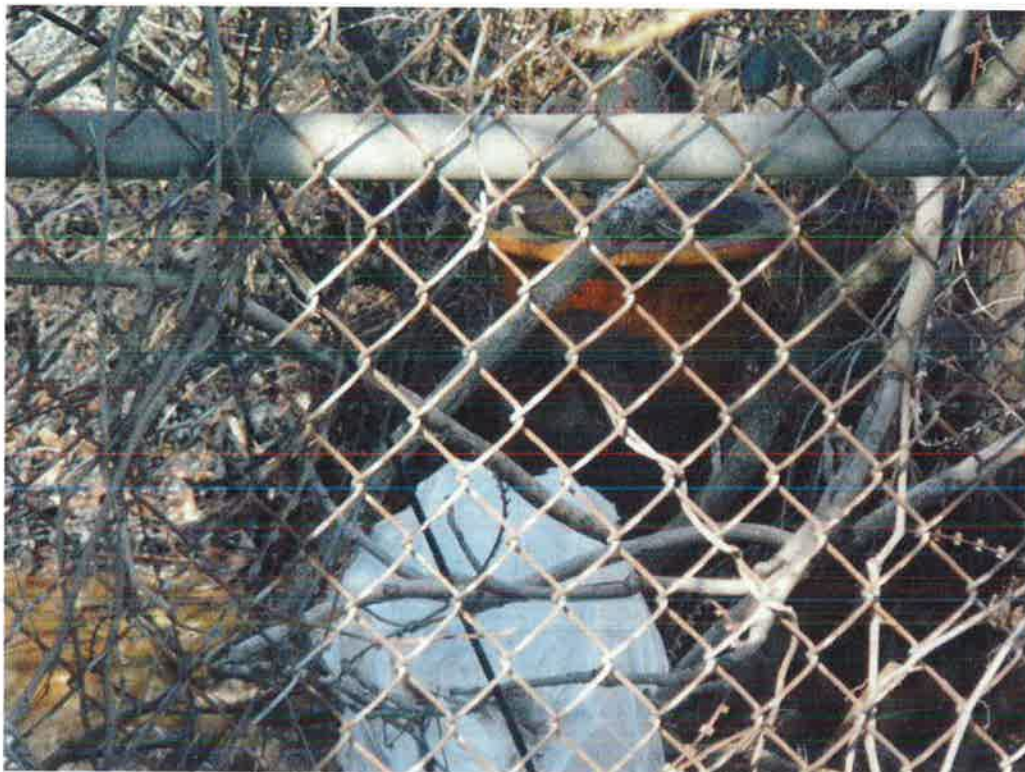
Photographs 6 and 11 in Appendix B) and so has not been pumped out or cleaned in the 15 years he has worked there.

Observation 10: According to Mr. Bullock quarterly visual assessments of stormwater pollution have not been conducted or documented. Mr. Bullock stated the Facility did not have a stormwater outfall due to the berms that had been placed around the perimeter to contain runoff. However, Mr. Bullock was unsure where the overflow (riser structure) to the large runoff collection pond discharged if levels reached the overflow (see Photographs 6 and 11).

Photograph 6. The riser in the large runoff collection pond.

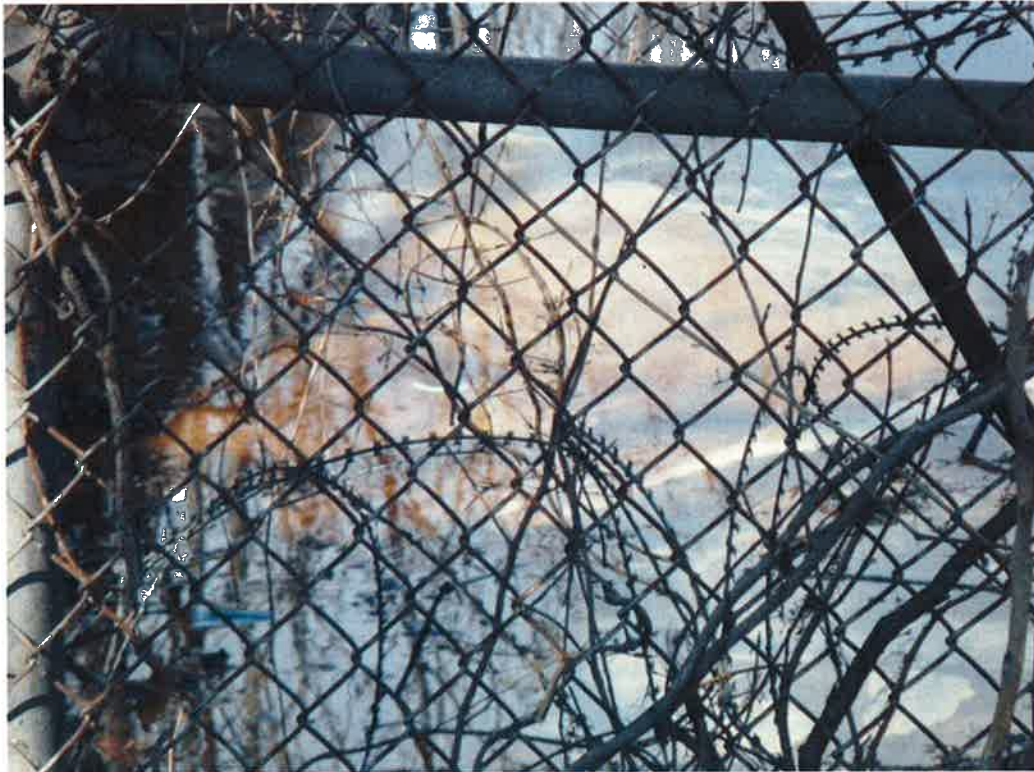
Photograph 7. Close up view of the sheen on the large runoff collection pond.

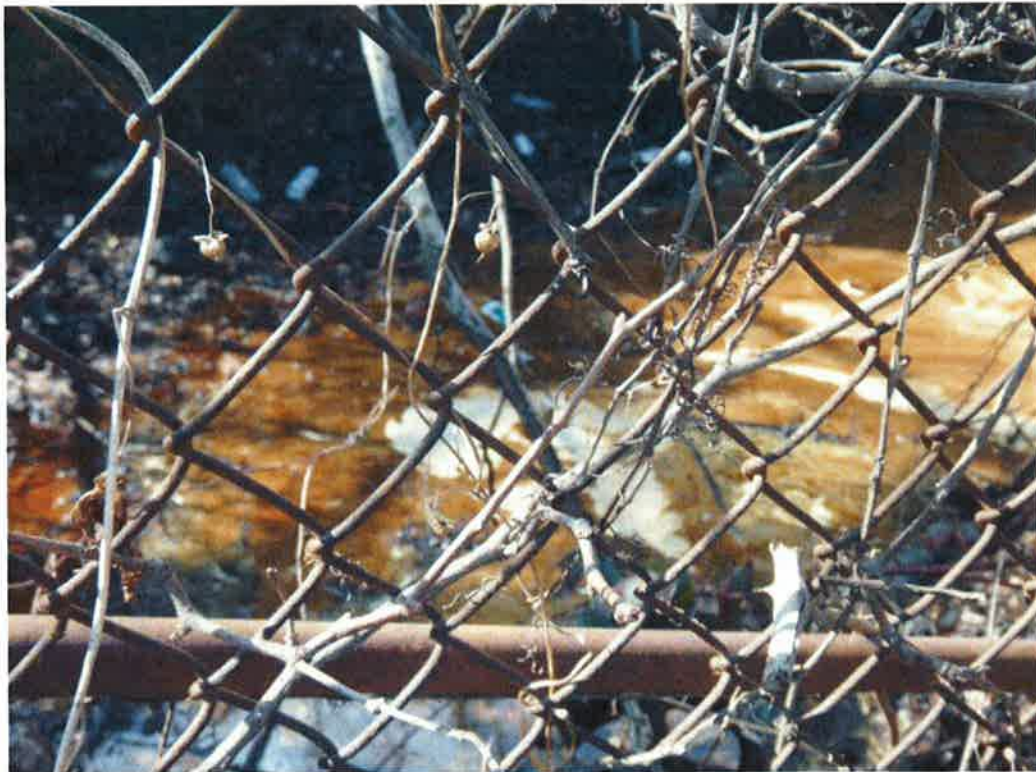
Photograph 8. Alternate view of the sheen on the large runoff collection pond.

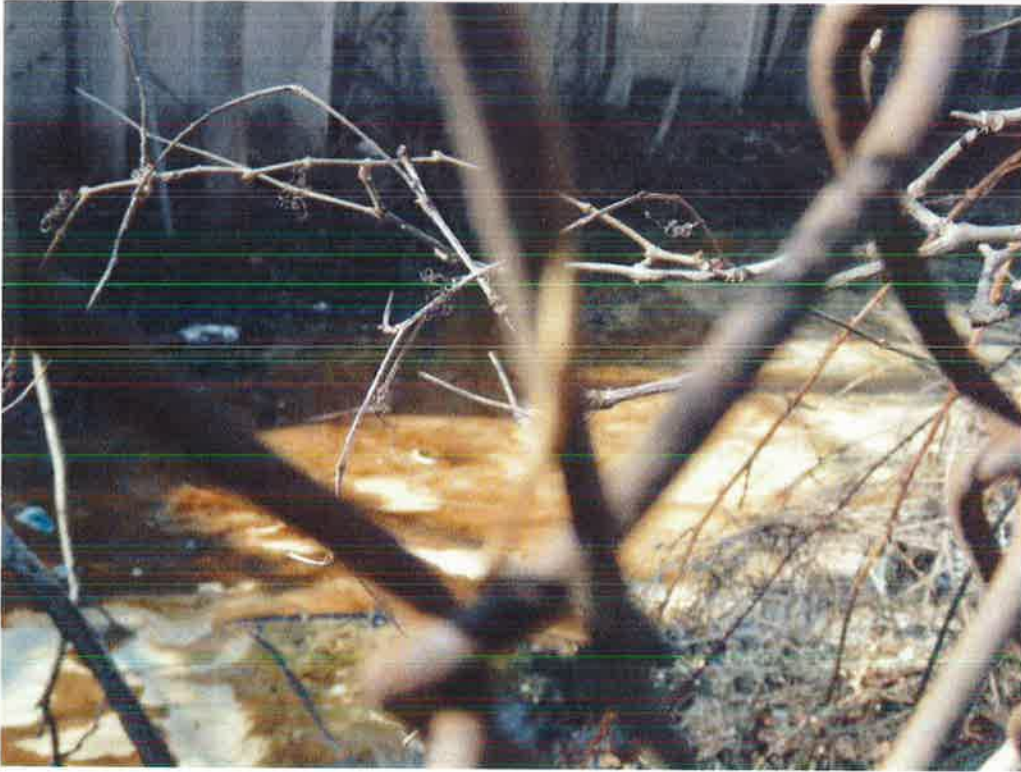
Photograph 9. **View of the sheen on the large runoff collection pond.**

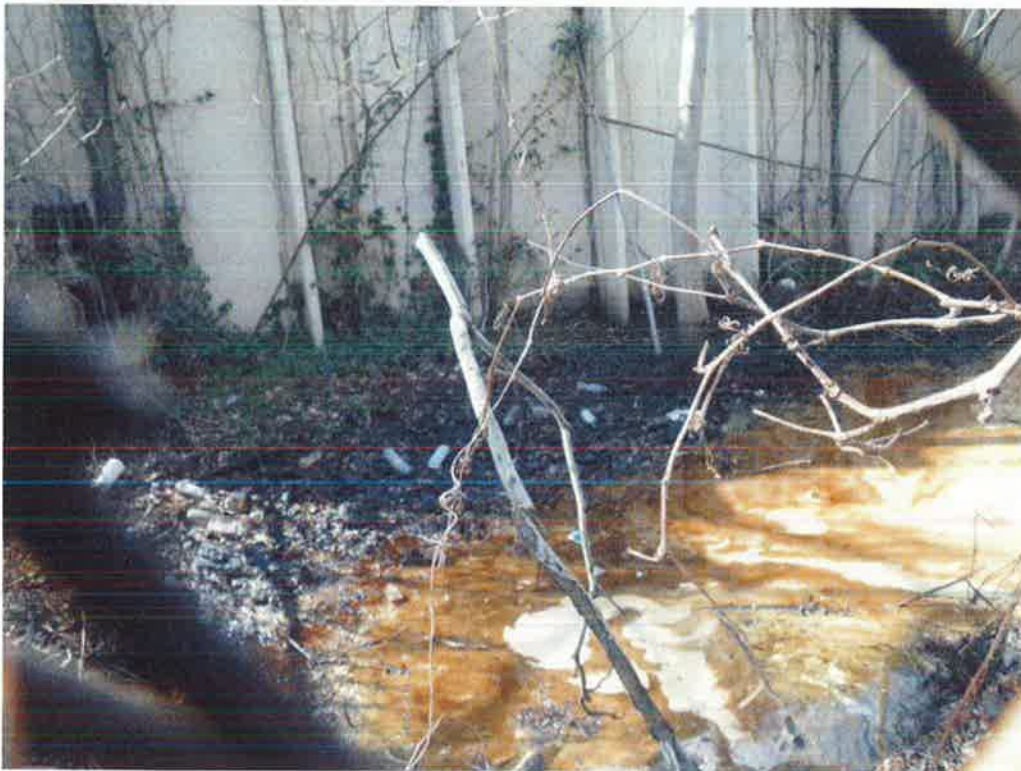
Photograph 10. **View of the sheen on the large runoff collection pond.**

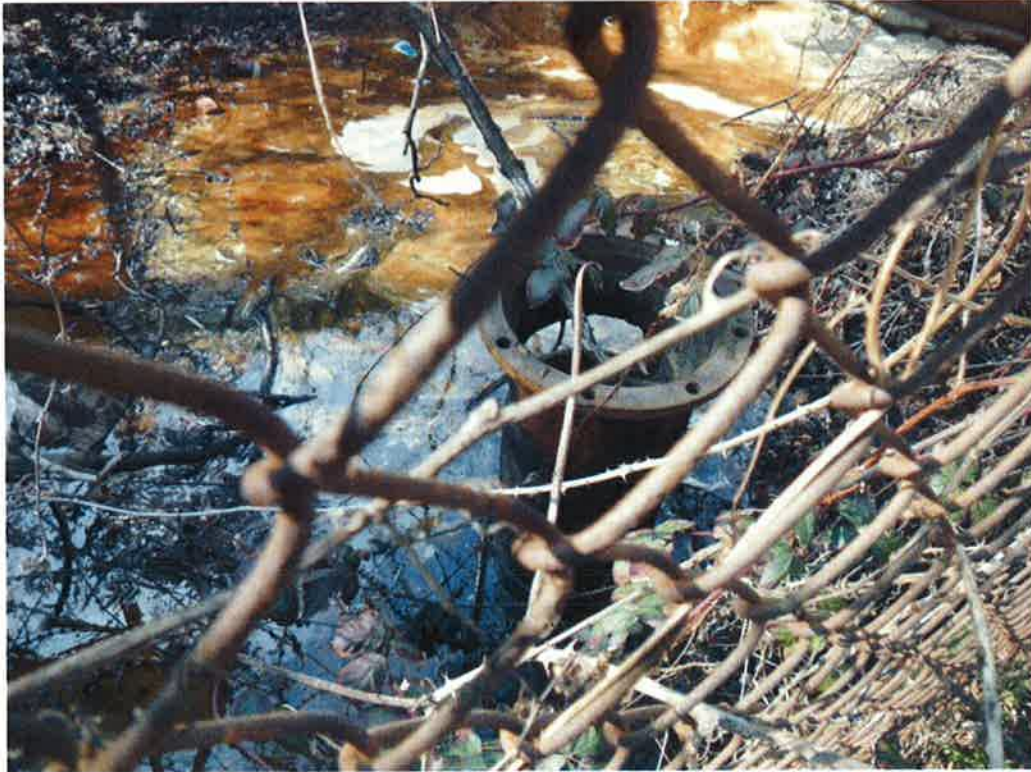
Photograph 11. View of the sheen on the large runoff collection pond with the riser.

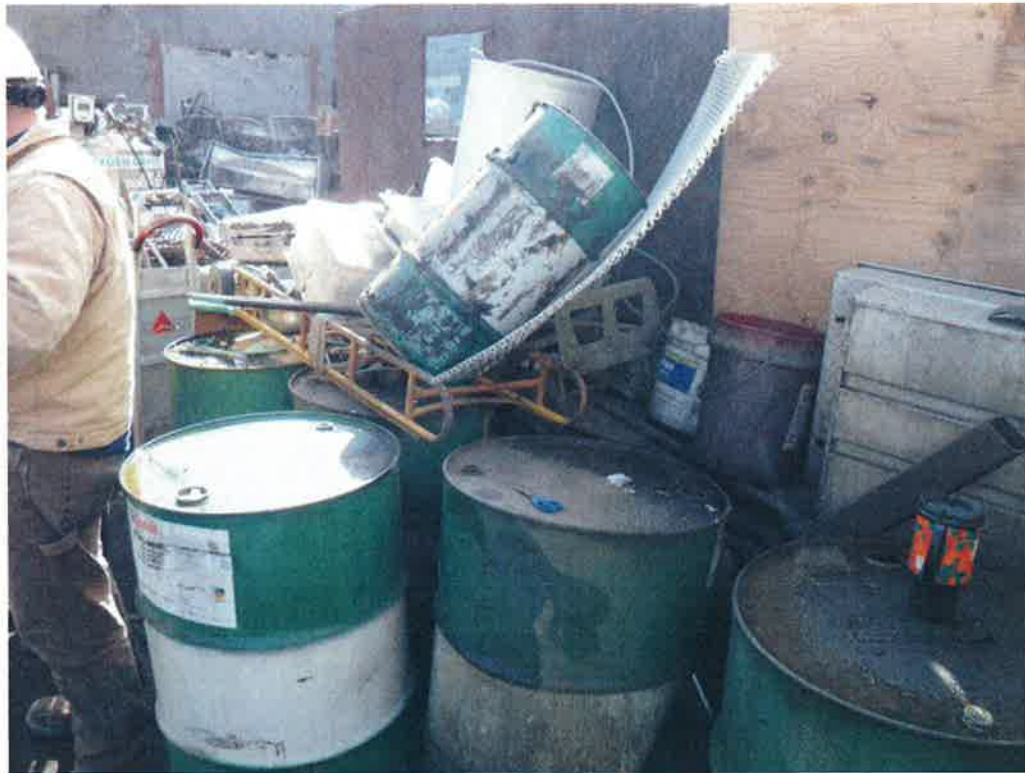
Observation 5: The EPA inspection team observed storage of what appeared to be lubricants and used oil filters in metal drums in various locations on site (See Photographs 3, 4, 15, 17, and 70 in Appendix B). Scrap engine parts were stored in cardboard boxes (see Photographs 65 and 66 in Appendix B). A 500-gallon diesel fuel tank was stored near Entrance 2. The diesel fuel tank was located in a high-traffic area with no barricades and was immediately adjacent to several oxygen tanks and propane tanks (see Photograph 53, 54, and 57 in Appendix B). When asked, Mr. Bullock was unsure if the oxygen and propane tanks were full or empty. The EPA inspection team did not observe secondary containment measures in place around the diesel fuel tank and small propane tanks. The EPA inspection team also observed additional fuel storage tanks including a 500-gallon diesel storage

Photograph 15. Storage of drums adjacent to small runoff collection pond.

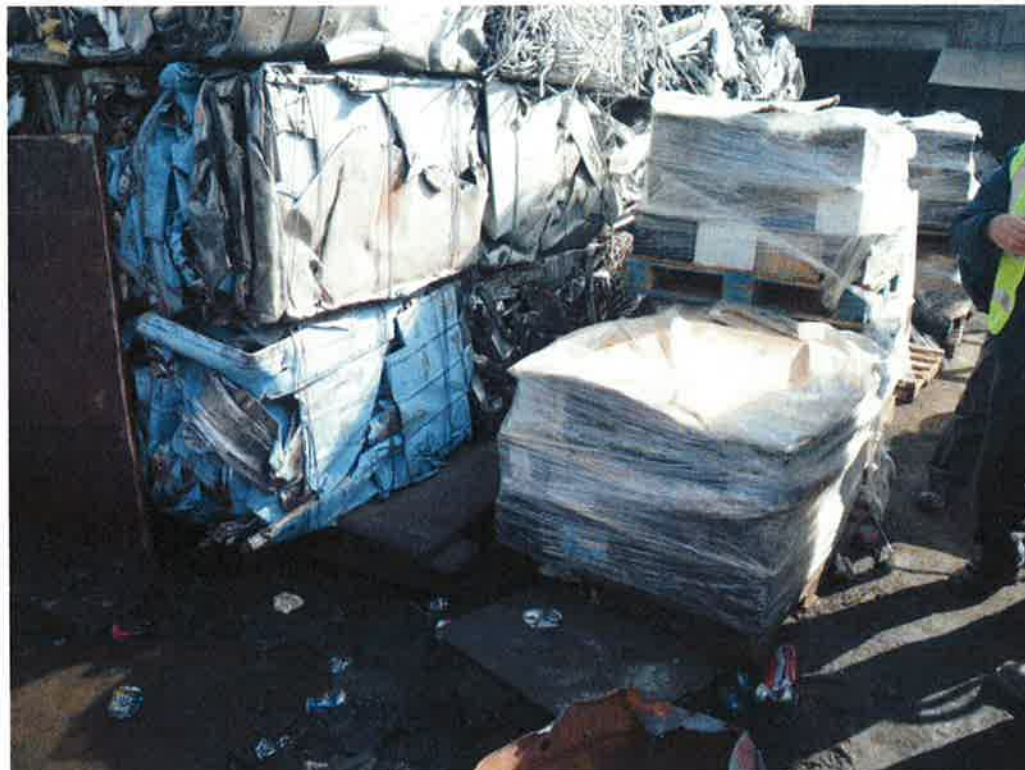
The EPA inspection team observed storage of sorted metal, engine parts, car batteries, leaking air conditioning units, and hydraulic equipment in various uncovered areas throughout the facility as well as on the property, that according to Mr. Bullock, is owned by DC (see Photographs 16, 24-28, 32-38, 41-45, 48-50, 63, and 64 in Appendix B).

Photograph 16. Pallets of used car batteries adjacent to small runoff collection pond.

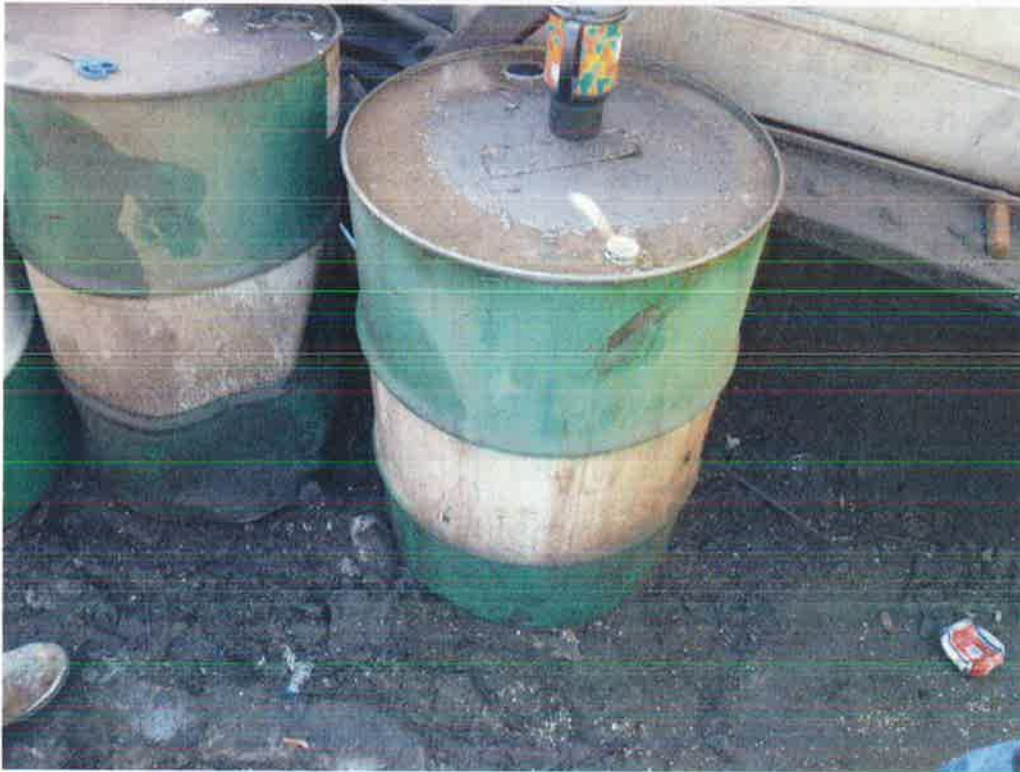
Photograph 17. **Alternate view of drums with what appeared to be oil staining.**

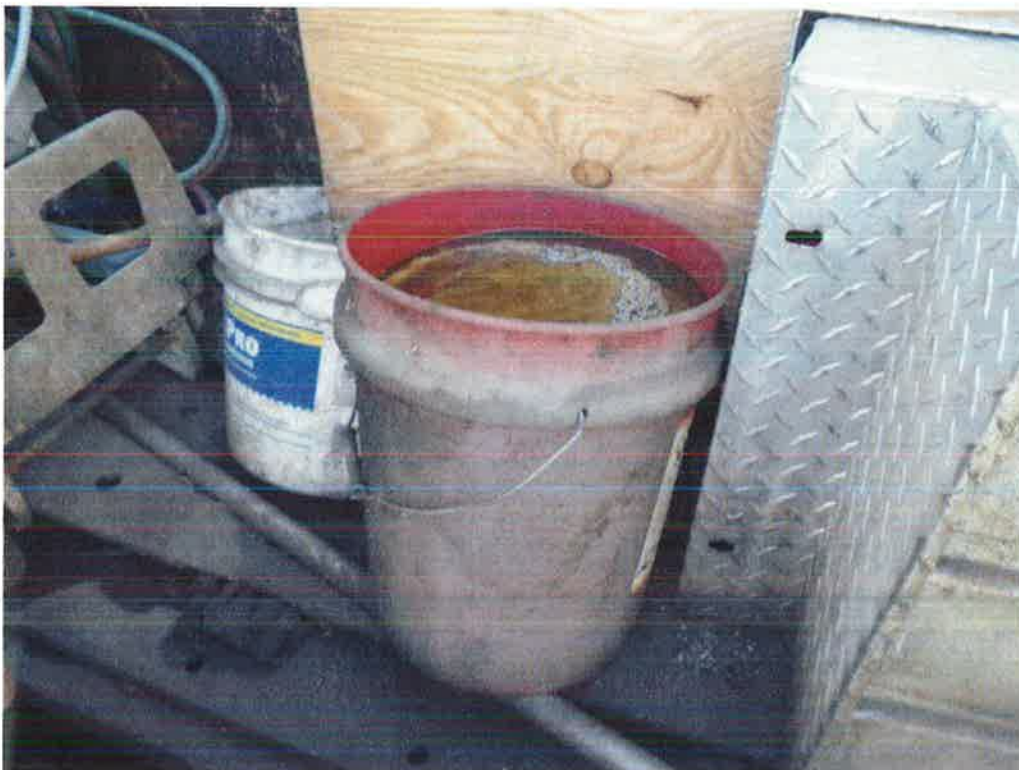
Photograph 18. **Close-up view of an open bucket also visible in Photograph 16.**

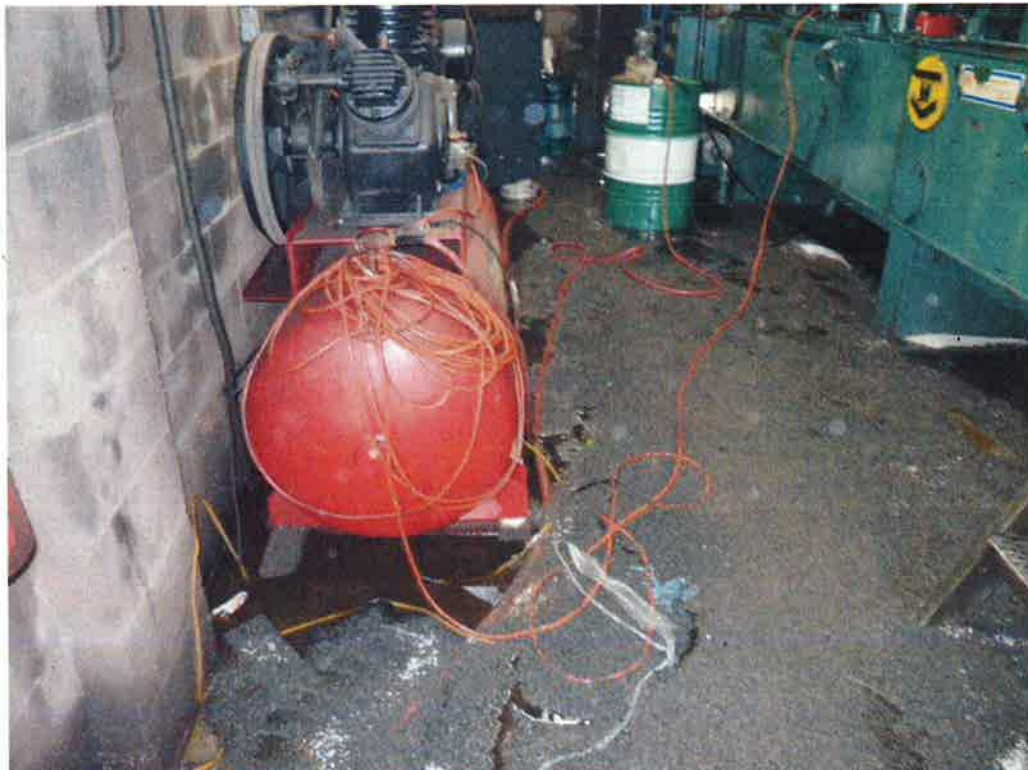
Observation 3: The EPA inspection team observed large amounts of staining and pooled fluids on the floor of the building from hydraulic equipment and 55-gallon drums (see Photographs 20 through 23 in Appendix B). The EPA inspection team observed saturated absorbent material that had been placed on some of the fluids. In addition, the door to the building led to small earthen trenches that conveyed liquids into the small runoff collection pond near the center of the facility (see Photograph 19 in Appendix B). According to Mr. Bullock, the small runoff collection pond is then pumped to the larger runoff collection pond.

Observation 6: The EPA inspection team observed what appeared to be oil staining and pools of oil present throughout the facility (see Photographs 67 and 68 in Appendix B). In some cases saturated absorbent material was present on top of the fluid (see Photograph 70 in Appendix B). The EPA inspection team observed leaking air conditioning equipment adjacent to the property fence line (see Photographs 48, 49, and 50 in Appendix B). As stated in observation 3, the EPA inspection team observed the inside of a small building containing hydraulic equipment. The floors had saturated absorbent material located near the drums and hydraulic equipment, in addition to pooled fluids underneath the hydraulic machinery (see Photographs 20-23 in Appendix B).

Photograph 20. **Pooled fluids and saturated absorbent materials.**

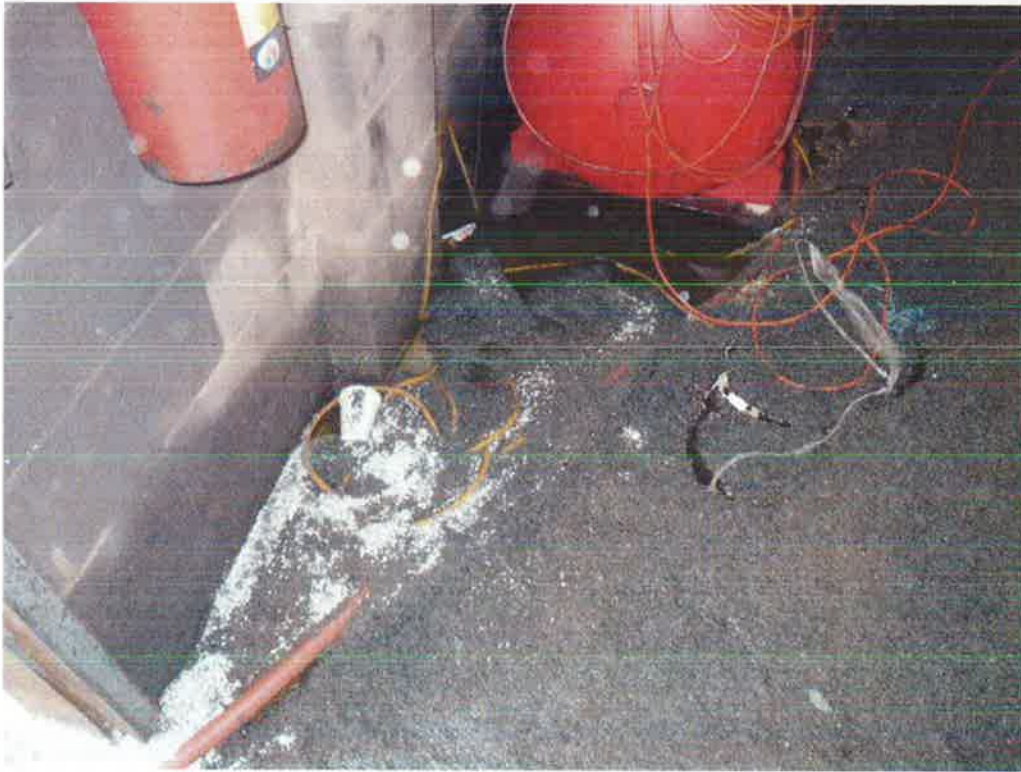
Photograph 21. **Alternate view of Photograph 20.**

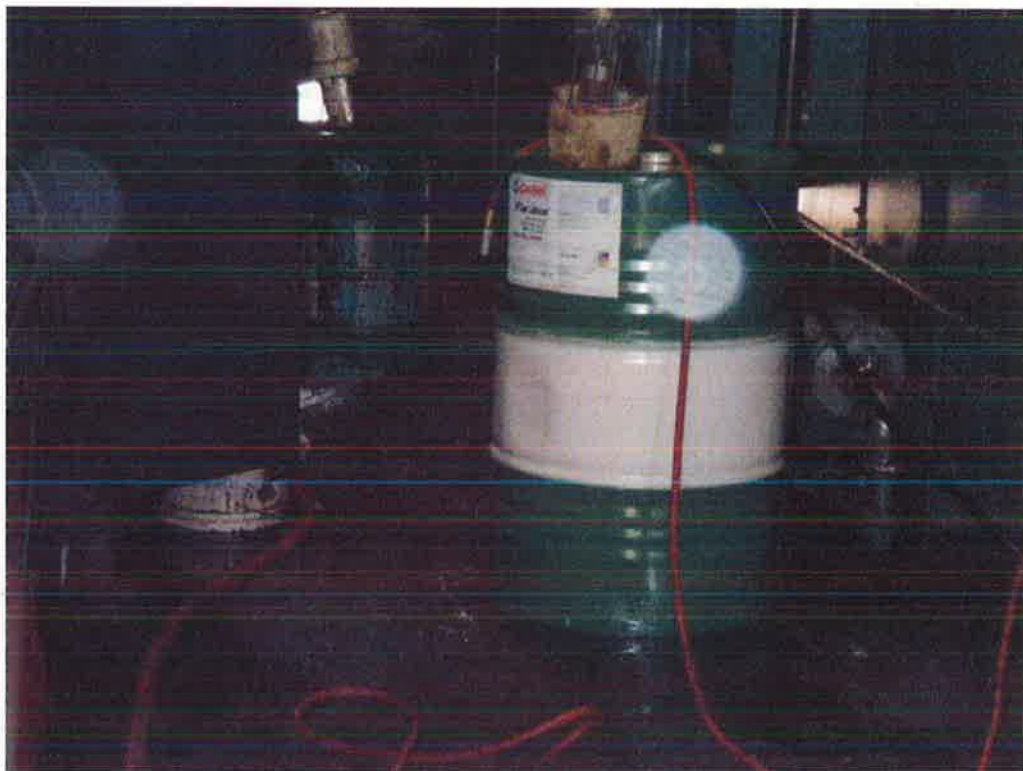
Photograph 22. **Close-up of two tanks in the building leaking onto the floor.**

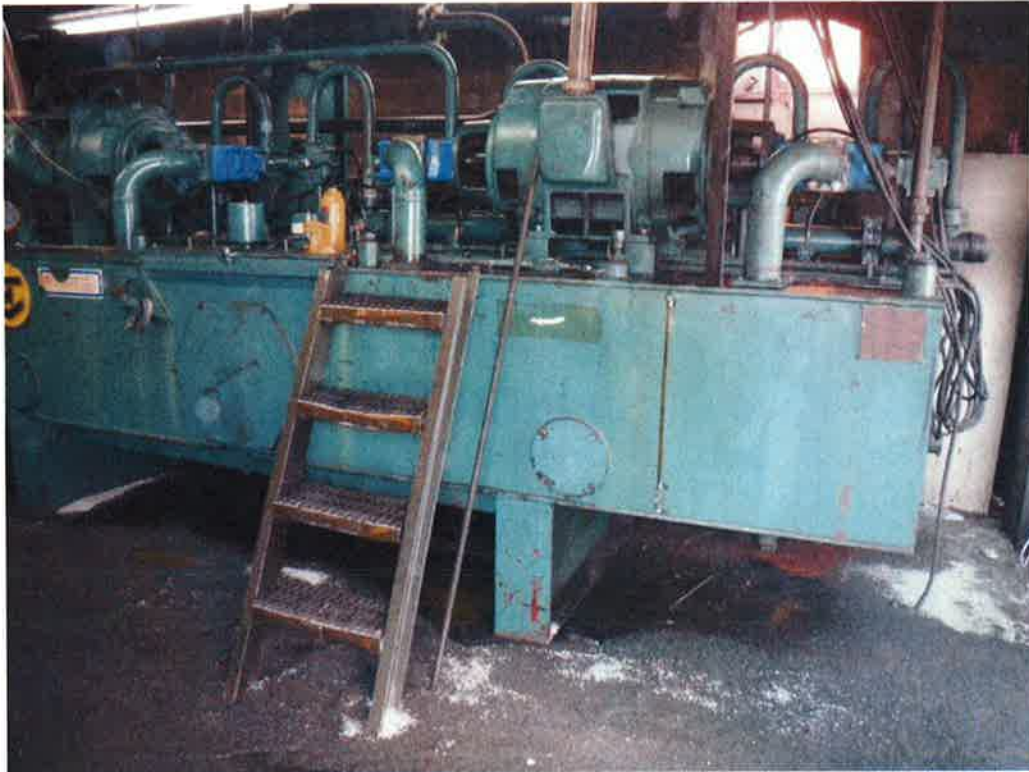
Photograph 23. **Hydraulic machinery with what appears to be oil underneath.**

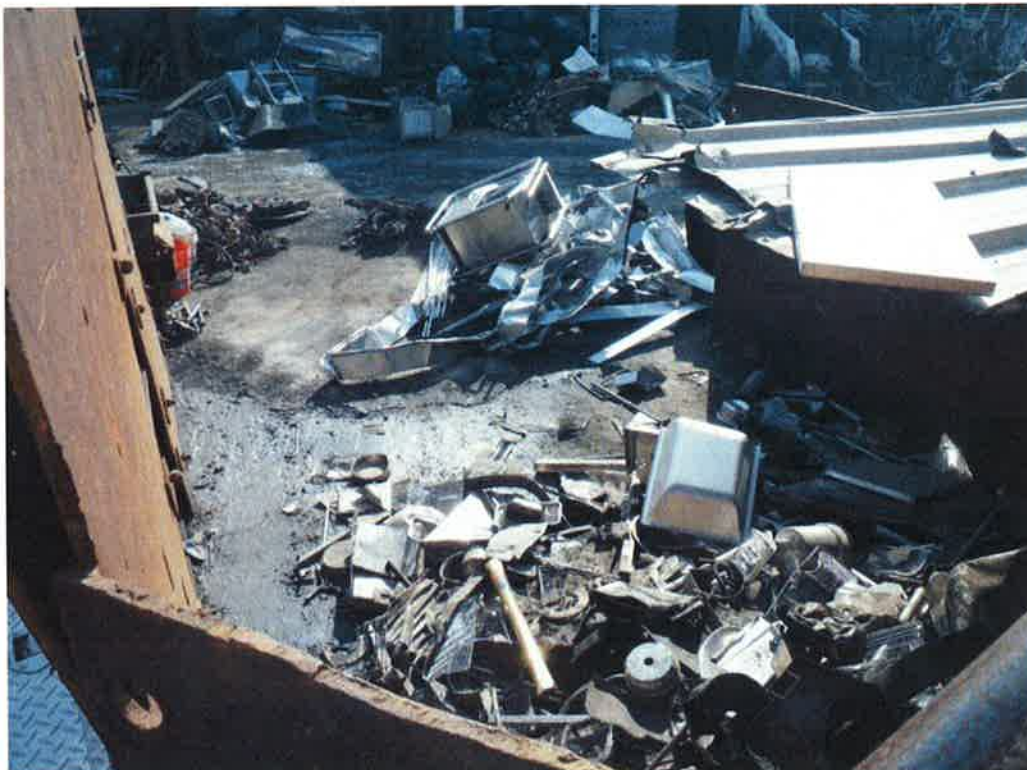
Photograph 24. **Debris from metal separation.**

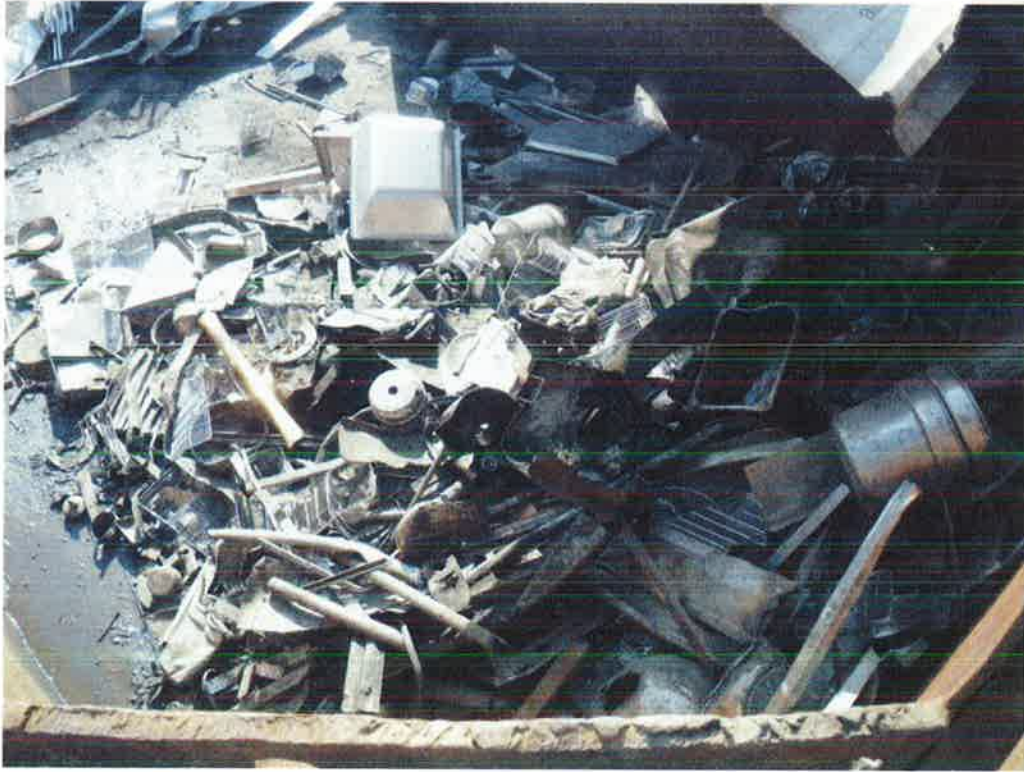
Photograph 25. **Alternate view of the debris including fluid pooling to the left.**

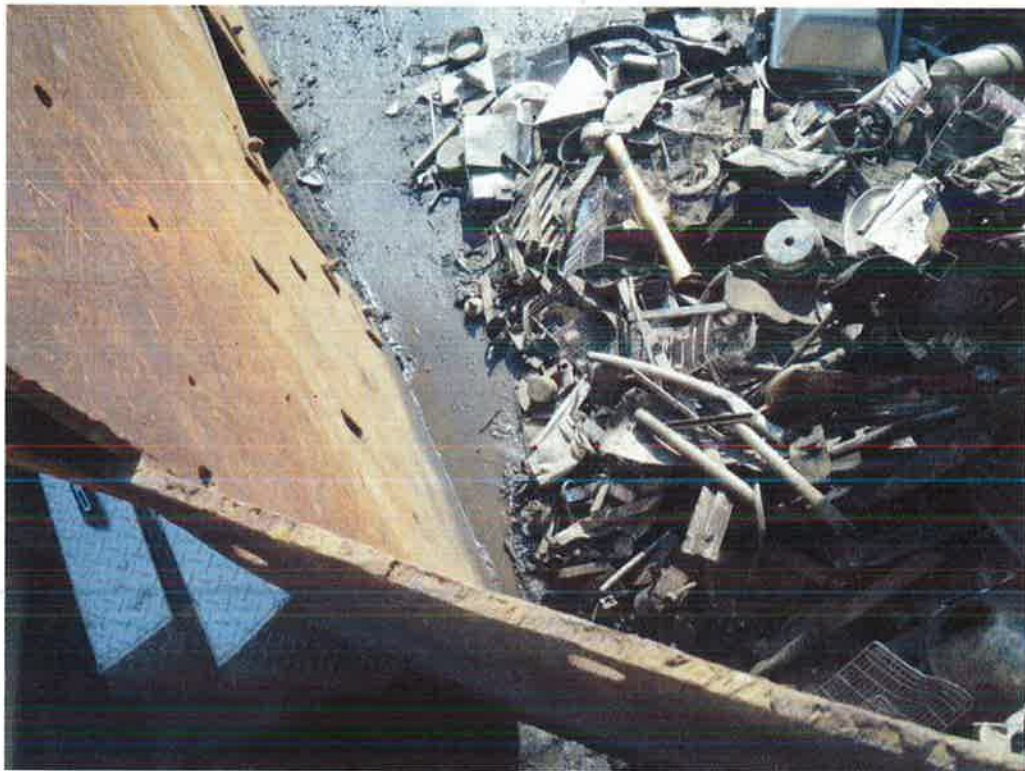
Photograph 26. **Alternate view of the fluid pooling towards the trench.**

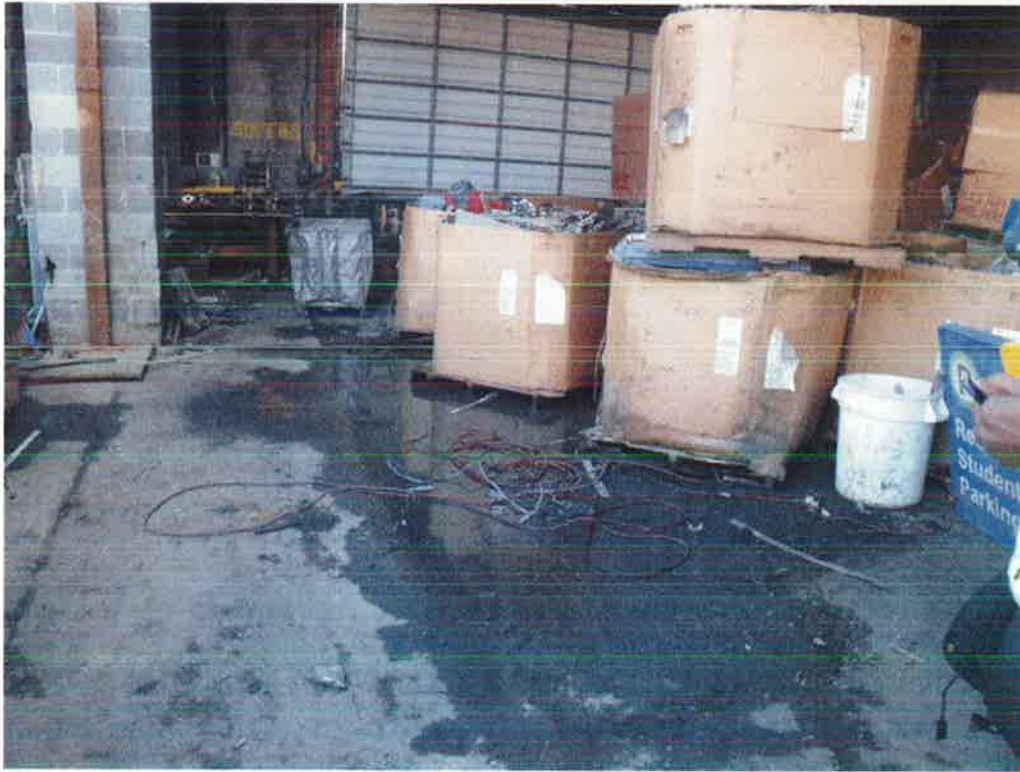
Photograph 33. Heavy staining on the concrete floors.

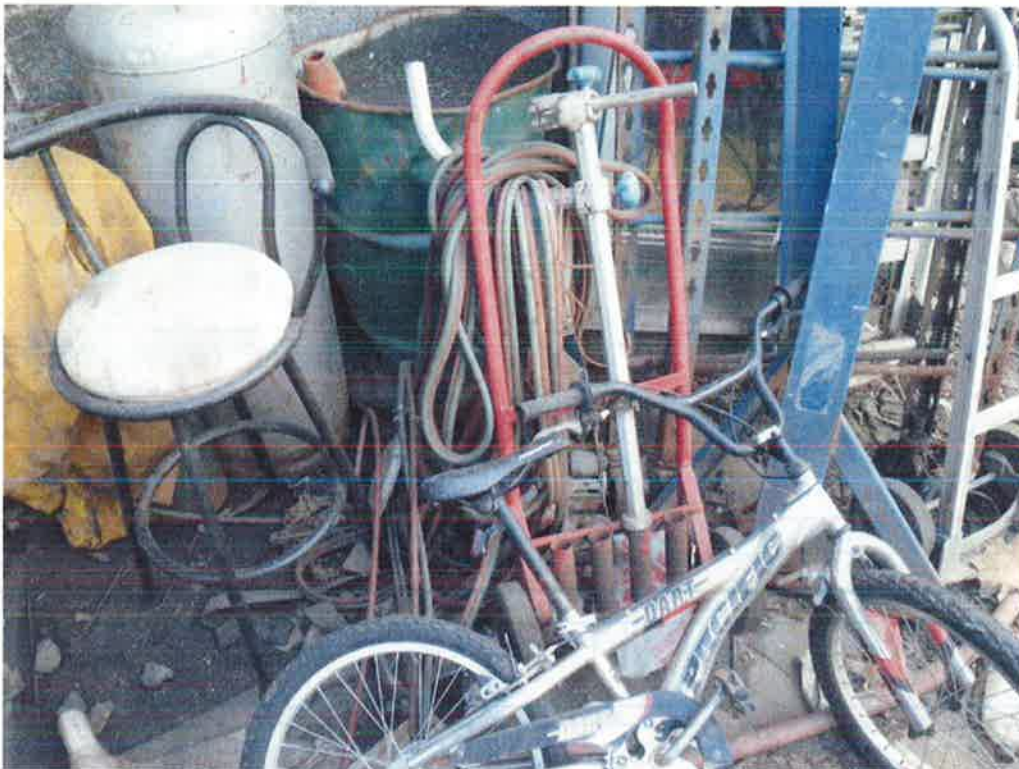
tank and numerous 55-gallon drums, without secondary containment, of what appeared to contain oils (see Photographs 34 and 44).

Photograph 34. Debris adjacent to the large runoff collection pond.

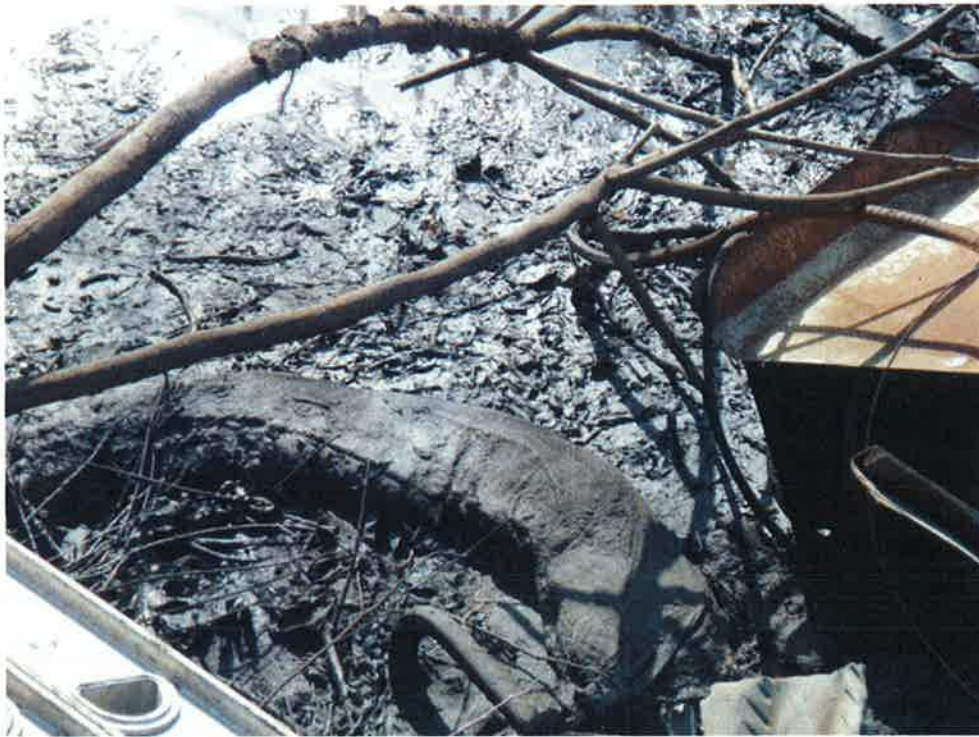
Photograph 39. Saturated absorbent sock at the northern end of the large runoff collection pond.

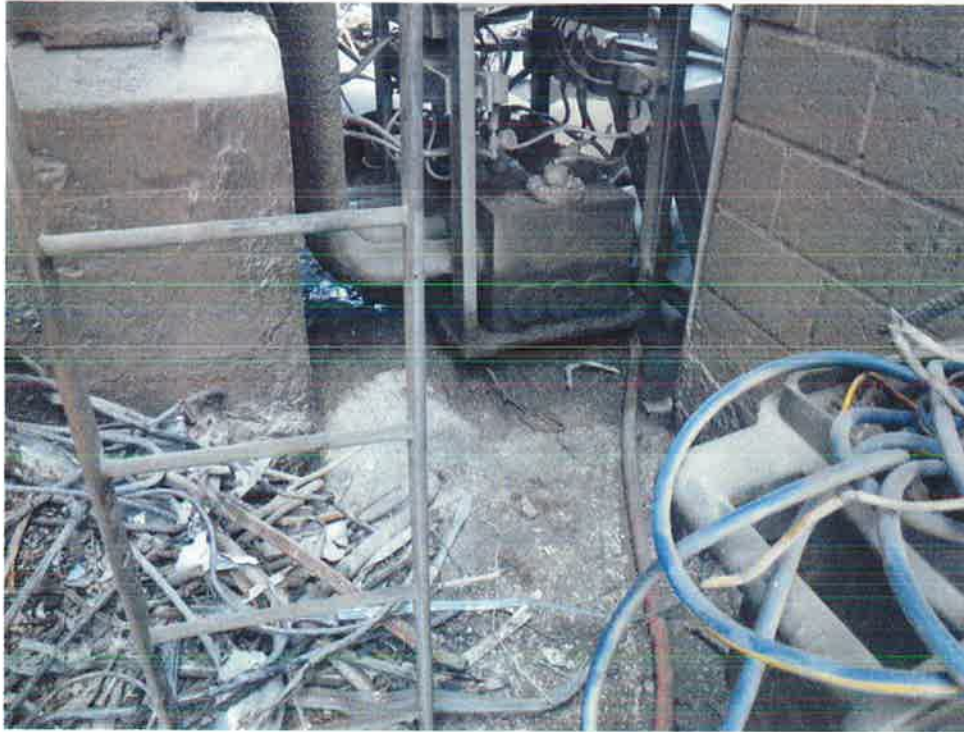
Photograph 45. Fluid leaking from under the conveyor belt of the “crusher”.

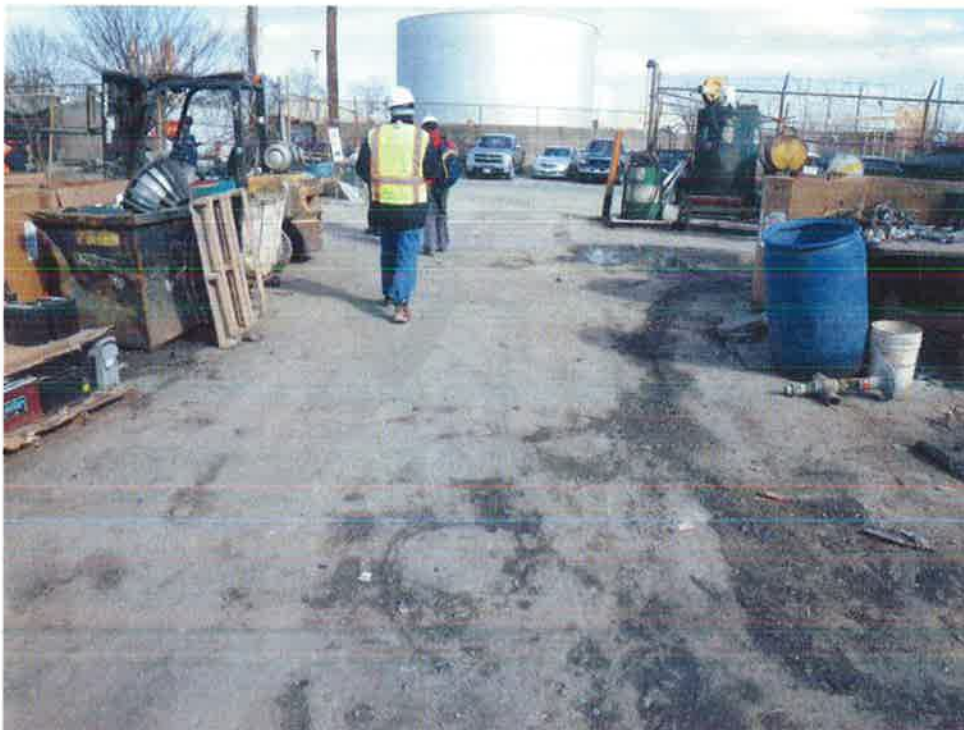
Photograph 46. View of Entrance 1 from the inside the yard showing staining on the ground.

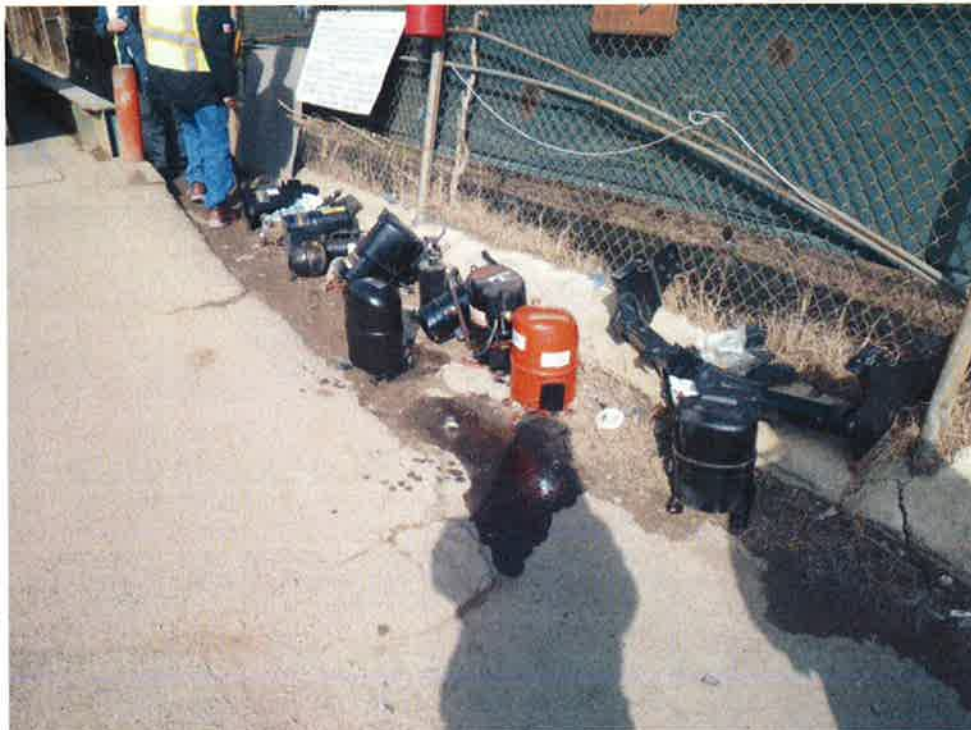
Photograph 48. Air conditioning units, some leaking fluids.

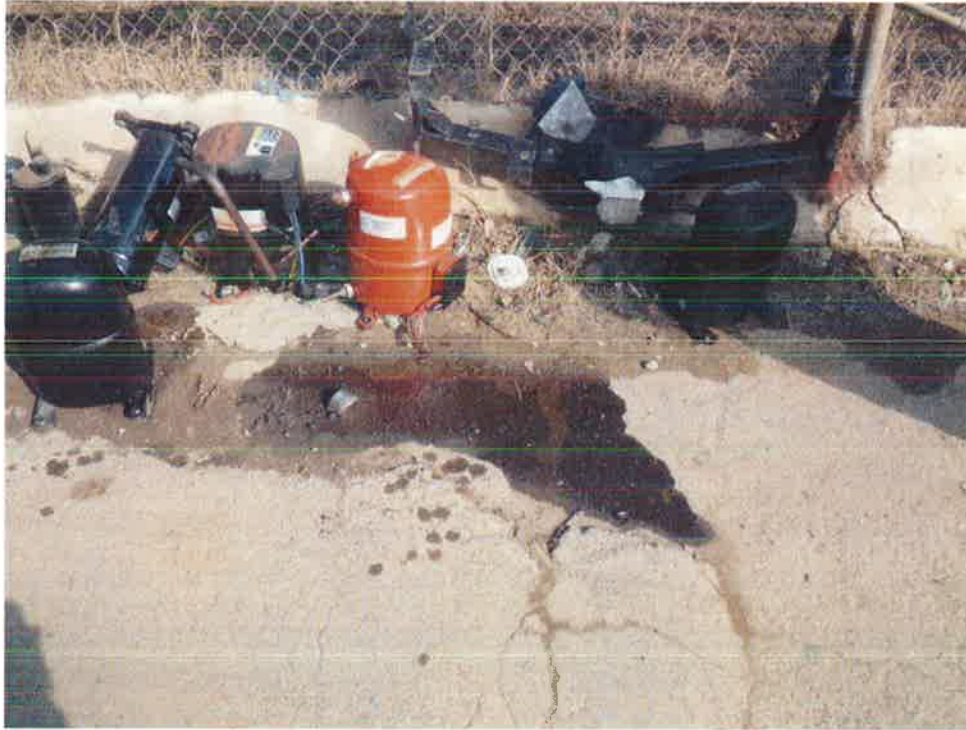
Photograph 49. Close-up view of the air conditioning units from Photograph 48.
